# **Test Report**

## ANSI/CAN/UL9540A

Test Method for Evaluating Thermal Runaway Fire **Propagation in Battery Energy Storage Systems** [Unit Level]

Report Number: CQES220800015301

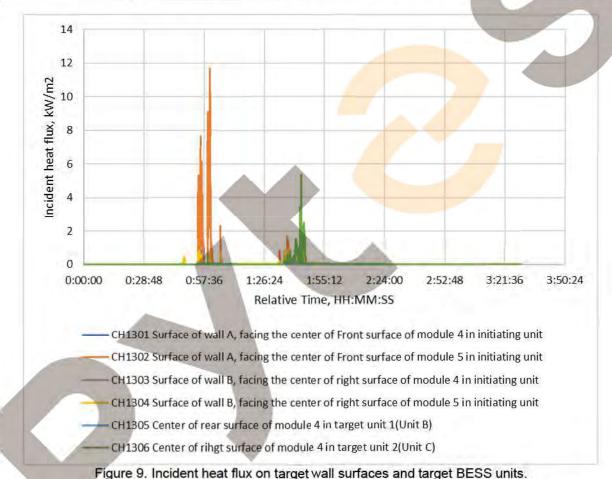
Maximum incident heat flux on target units and wall sur	faces	
---	-------	--

Heat Flux Sensor ID	Description of location			
CH1301	Surface of wall A, facing the center of front surface of module 4 in initiating			
CH1302	Surface of wall A, facing the center of front surface of module 5 in initiating unit			
CH1303	Surface of wall B, facing the center of right surface of module 4 in initiating unit			
CH1304	Surface of wall B, facing the center of right surface of module 5 in initiating unit			
CH1305 Center of rear surface of module 4 in target unit 1(Unit B)				
CH1306 Center of rihgt surface of module 4 in target unit 2(Unit C)
